Bluefield State College

**CAMPUS DEVELOPMENT PLAN
2021 UPDATE**

SMITHGROUP

Prepared December 2020-April 2021

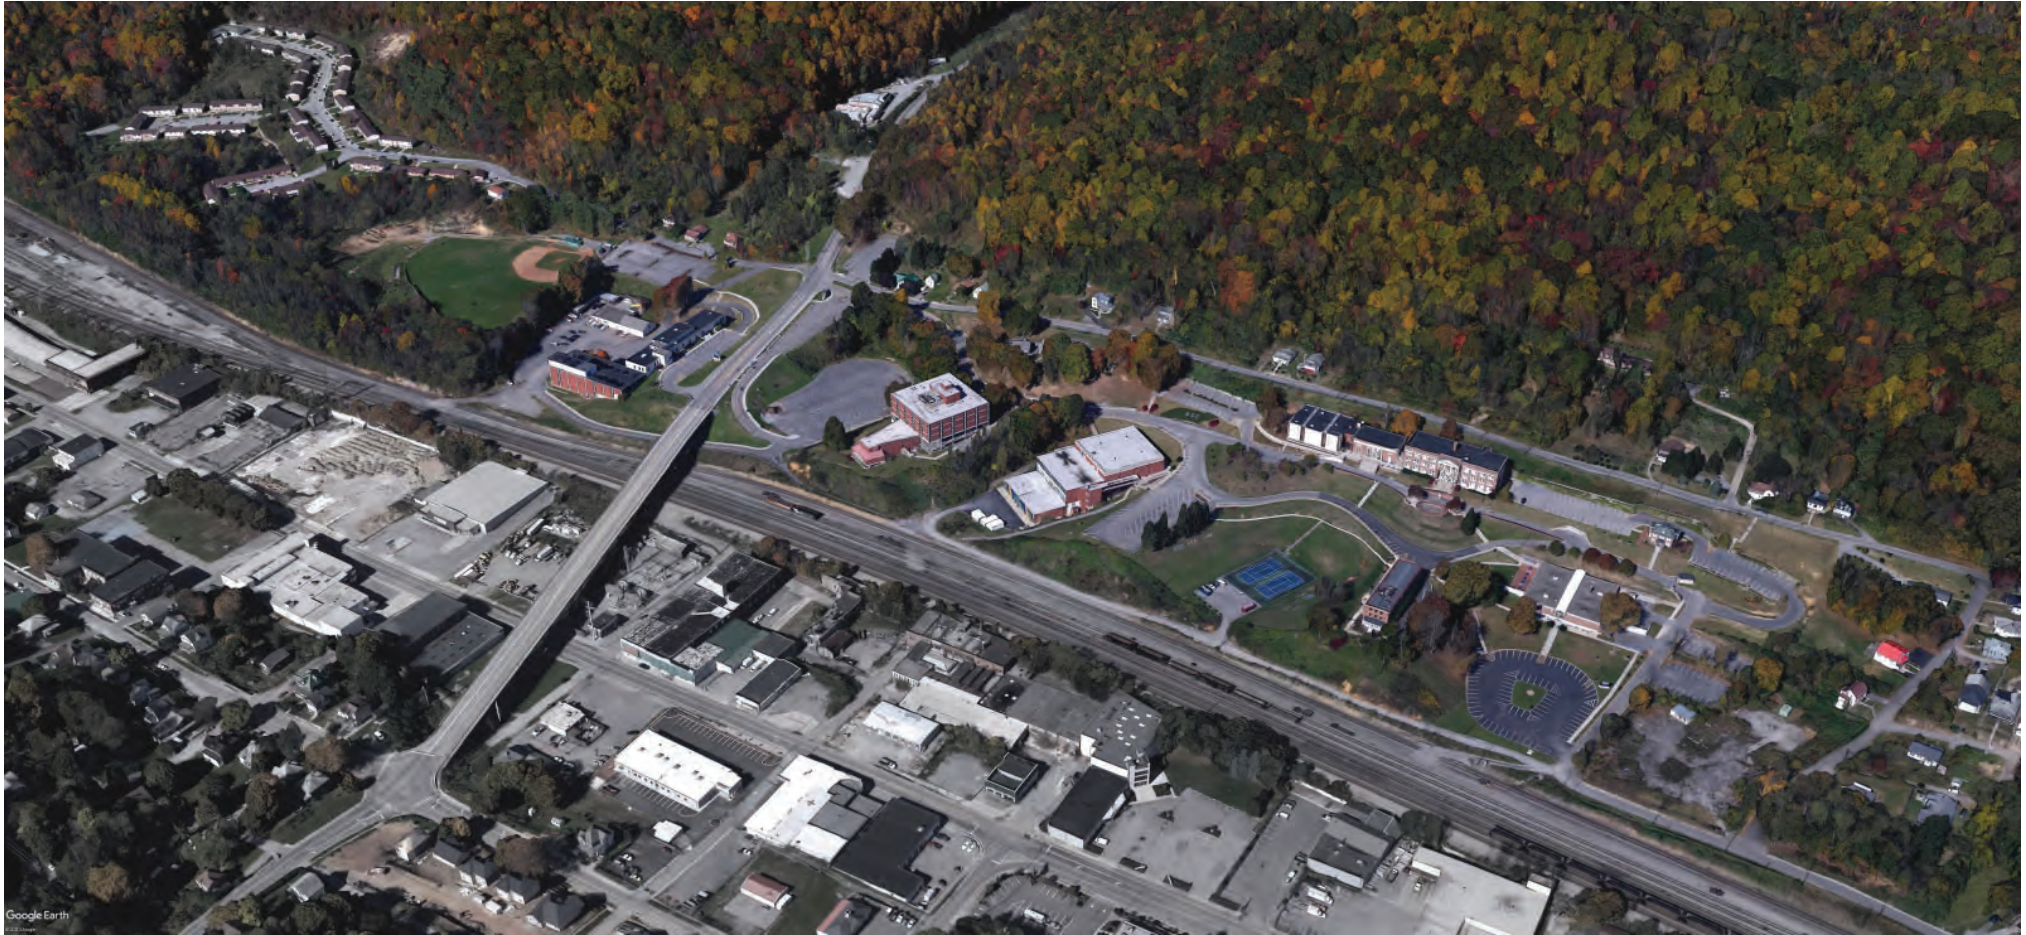
MAIN CAMPUS EXISTING CONDITIONS

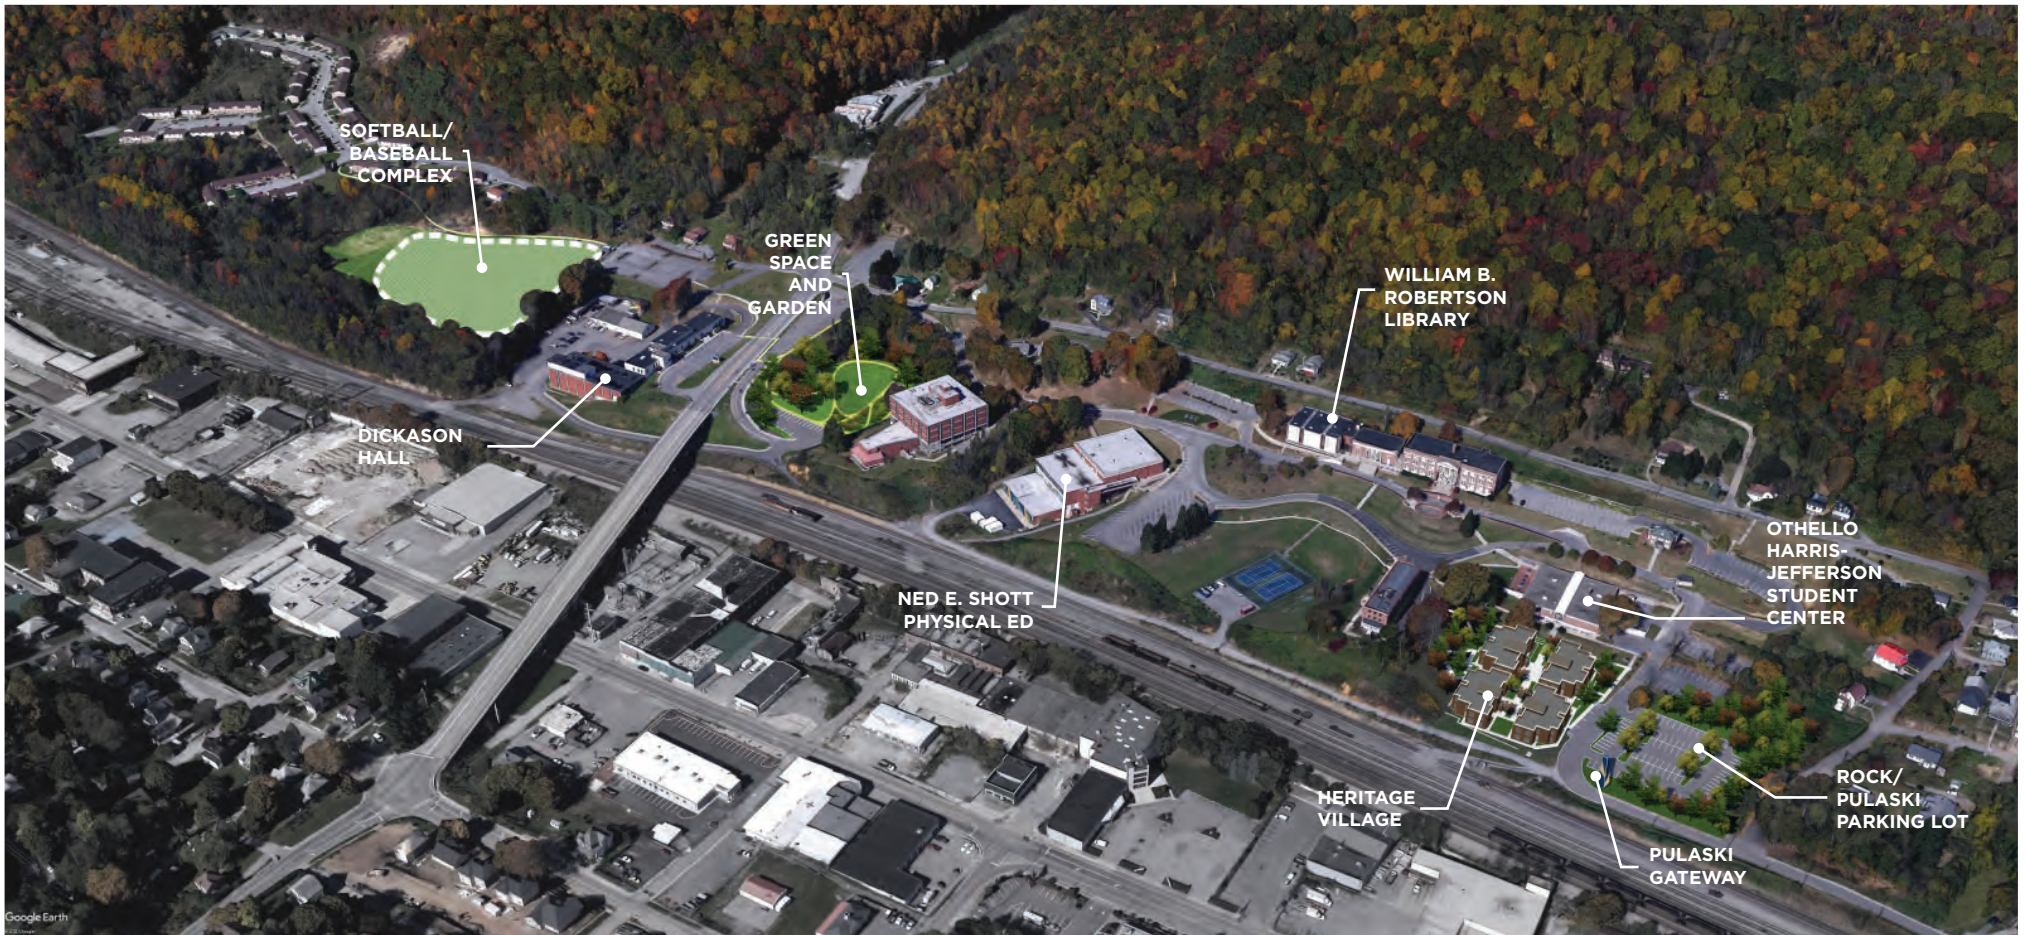
MAIN CAMPUS PLANNED IMPROVEMENTS

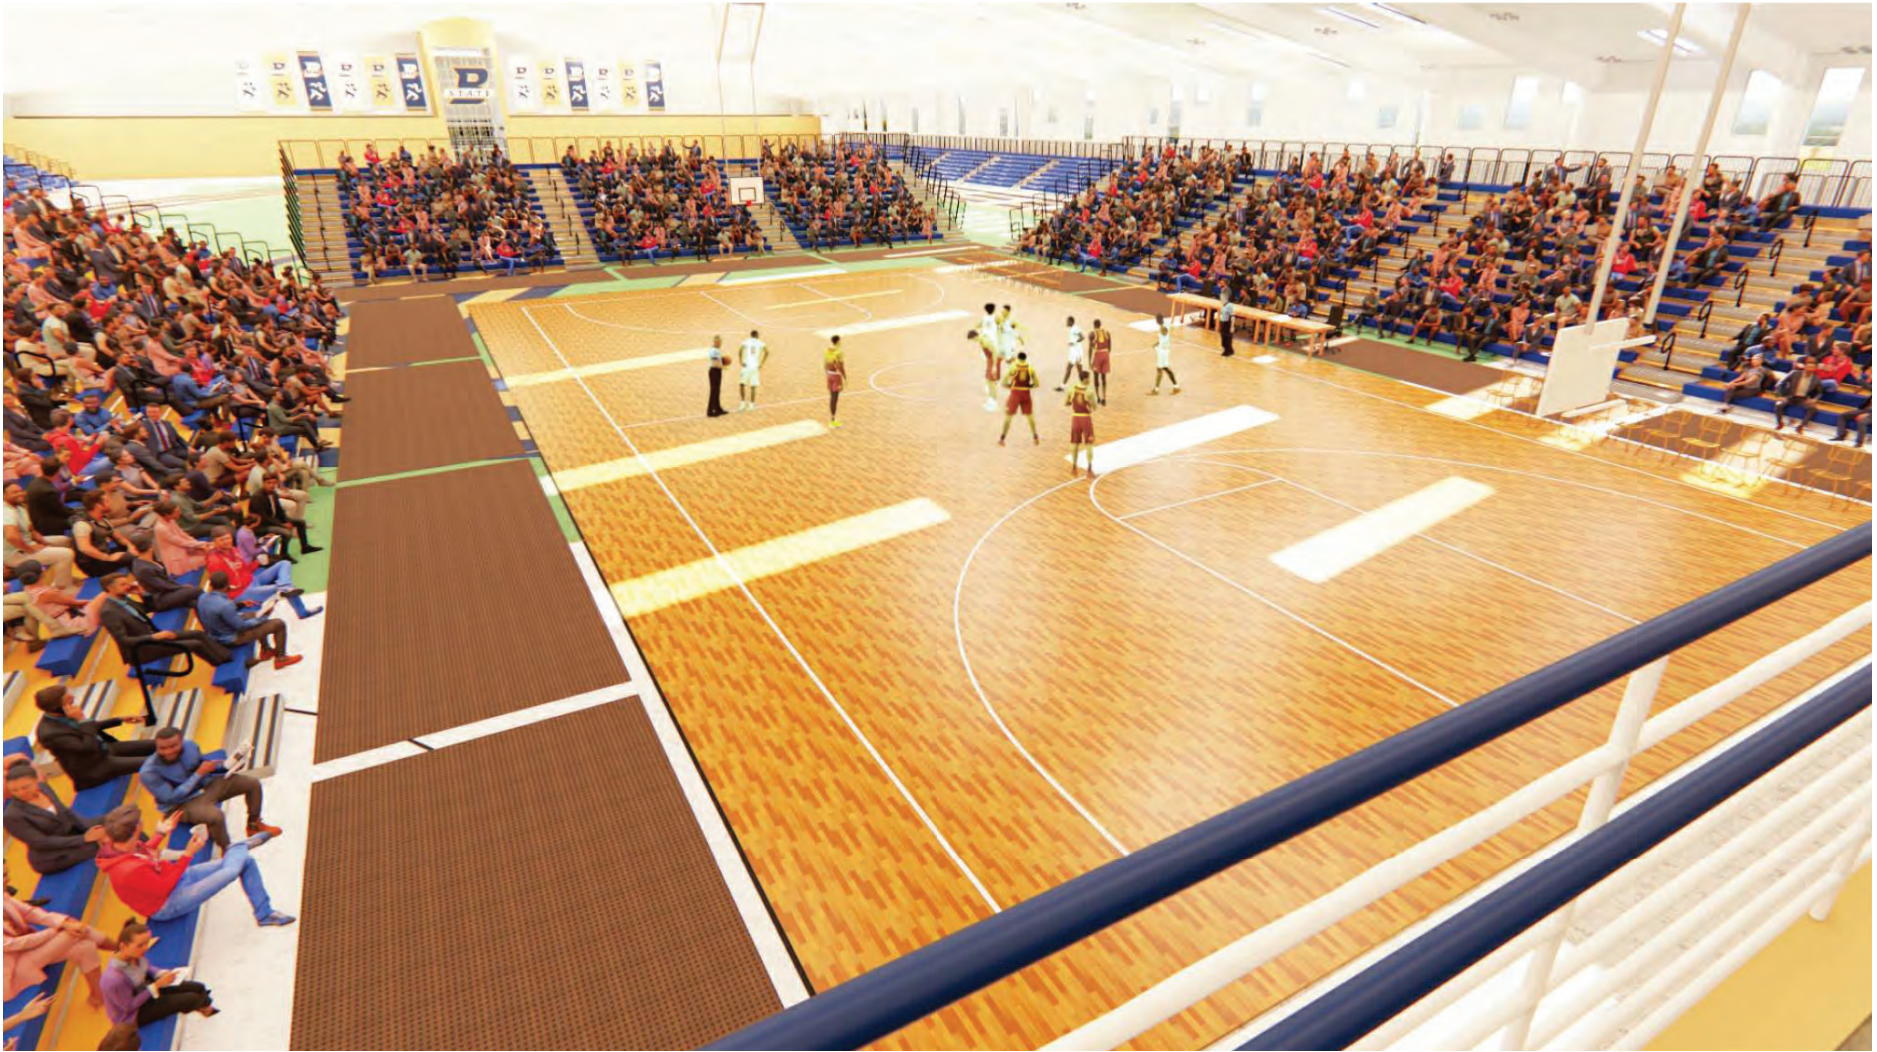
CONVOCATION CENTER ARRANGED FOR BASKETBALL PLAY (EDWARD TUCKER ARCHITECTS)

The College will pursue the construction of a new convocation center in the far west parking lot of the Medical Education Center property. This multi-use facility will include a NCAA 200 meter indoor track and be the future home of the Big Blue Indoor Track and Field team and other arena sports. Floor overlays and moveable bleachers will allow men's and women's basketball teams to play competition games in the facility. The facility will also support the College's intramural program and the indoor recreation needs of the student residents at the Bluefield State Medical Education Center, as well as the students residing on the main campus. The convocation center will also serve community needs and will be available to serve conference and trade shows for the region.

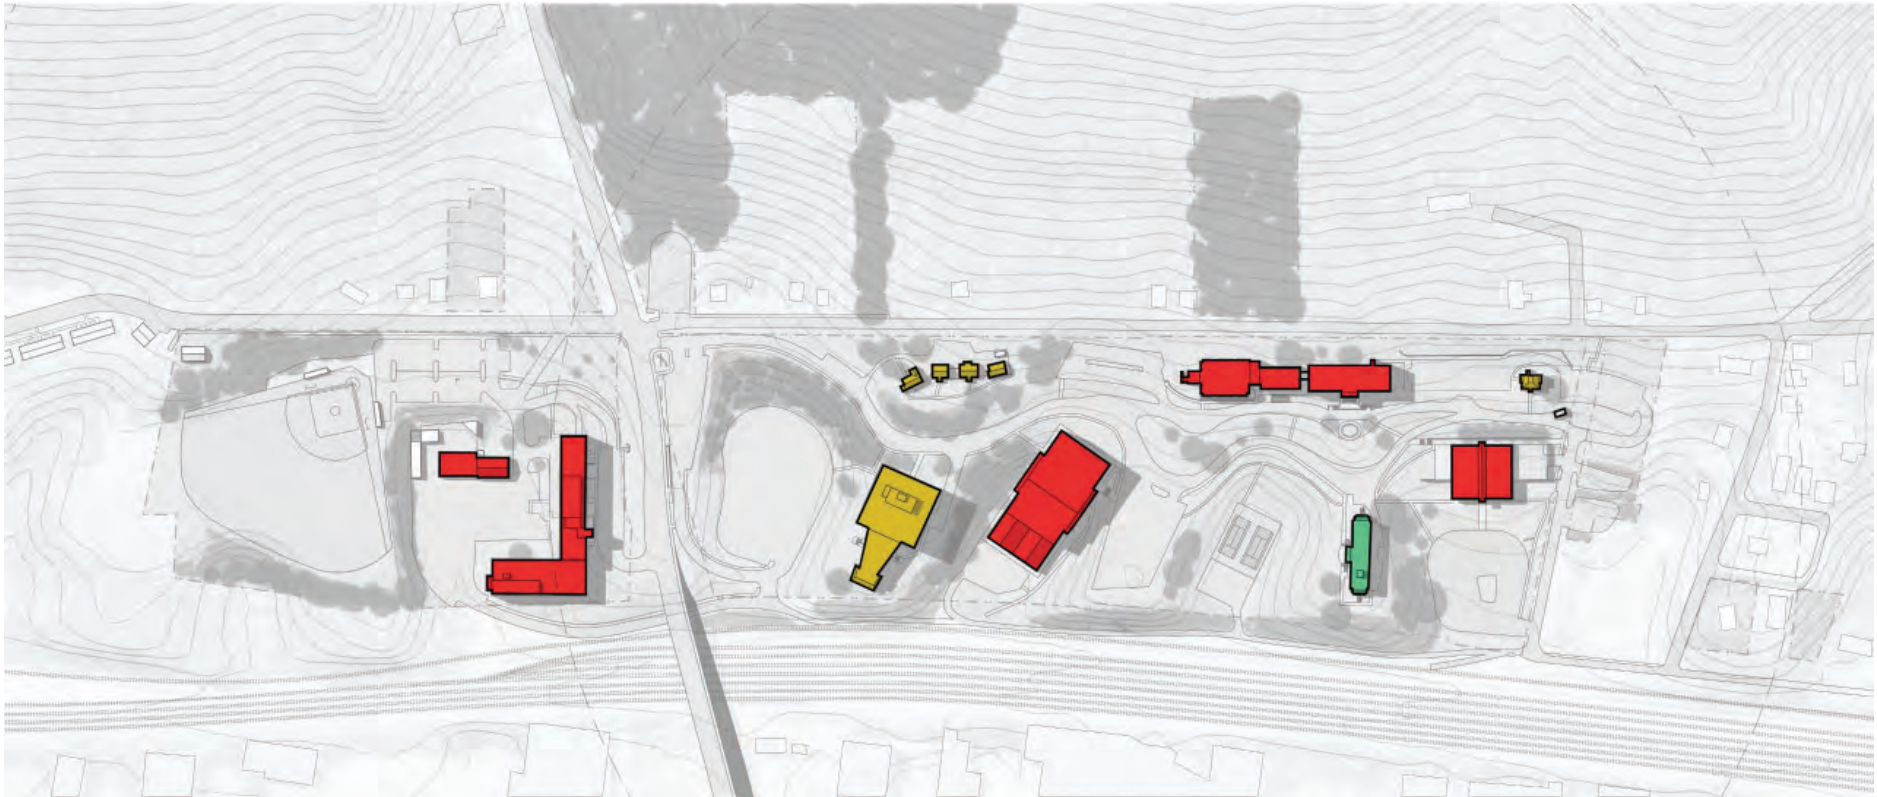
MAIN CAMPUS BUILDINGS BY OVERALL FACILITY RATING

See pages 110-111 description of Overall Building Condition and Overall Facility Rating.

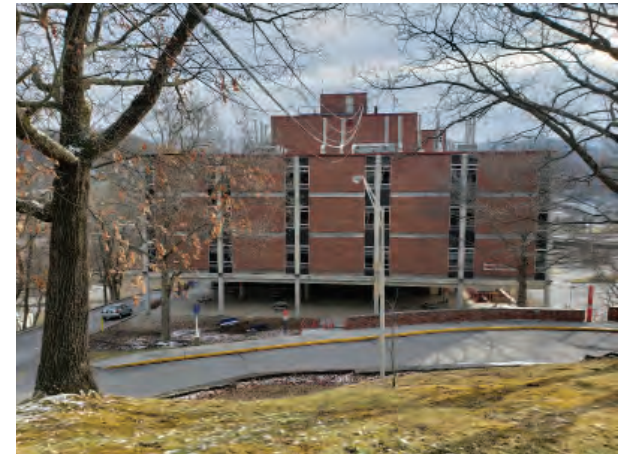
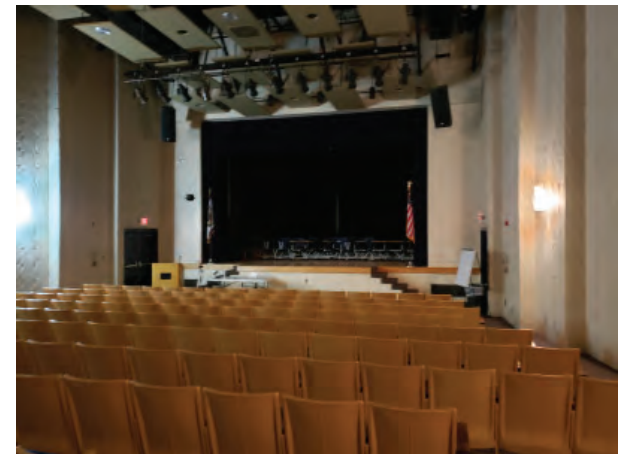
Brown-Gilbert Basic Science Building is a concrete framed building. The exterior façade consists of brick and exposed cast-in-place concrete. All exterior windows are aluminum, while the doors are a combination of aluminum and steel. The roof is a combination of a sheet asphalt roof system and standing-seam metal roof system.

The brick and concrete are in good condition with the exception of some minor cracking in the brick and several old wall pipe penetrations that need resealing. All existing windows and storefront, with the exception of new main entrance doors, are nearing the end of their expected life cycle and will ultimately need to be replaced. The existing asphalt roof system is generally in good condition. However, all wall-to-roof terminations will need to be repaired as the caulk is deteriorating in many locations. Additionally, the roof above the auditorium will soon be in need of replacement. The existing standing seam metal roof is functionally sound. However, the paint is delaminating on several panels. Although not a high priority at present, the College intends to replace the standing-seam metal roof be replaced. Several pieces of HVAC equipment are located within 10-feet of the roof edge. Guardrails for each of these pieces of equipment will be requested.

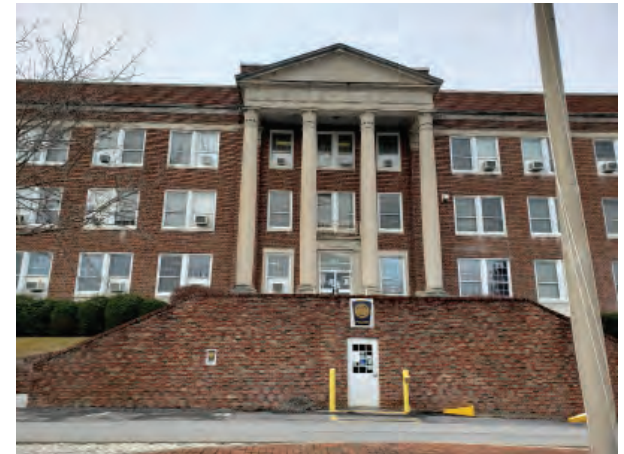
The brick and limestone are in good structural condition. The exterior façade

and stonework should be periodically professionally cleaned. There are several crawl space vents that do not have screens. Screens should be provided at all vents to block rodents. All existing windows are in fair condition, but window replacement should eventually be planned. The window caulking is deteriorating and lintels are rusting. Consideration should be given to recaulking the windows and repainting the lintels as preventative maintenance. The existing EPDM membrane roof system on the primary roof is in poor condition. There are signs of severe insulation delamination while soil and vegetation are preventing proper drainage. A complete roof replacement should eventually be considered. The existing chimney is also in poor condition. The chimney cap is damaged while the chimney walls are missing a significant amount of the brick mortar. It is recommended that the chimney be refurbished to prevent moisture infiltration. The slate portico roof is also in very poor condition and will ultimately need to be replaced along with the portico soffit. The iron railing above the main entrance is weathered

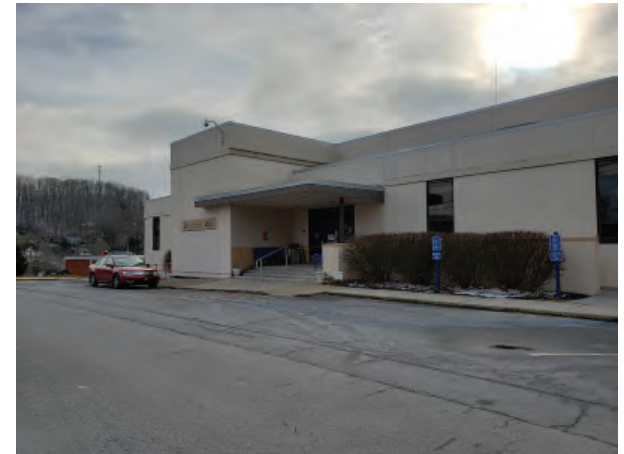
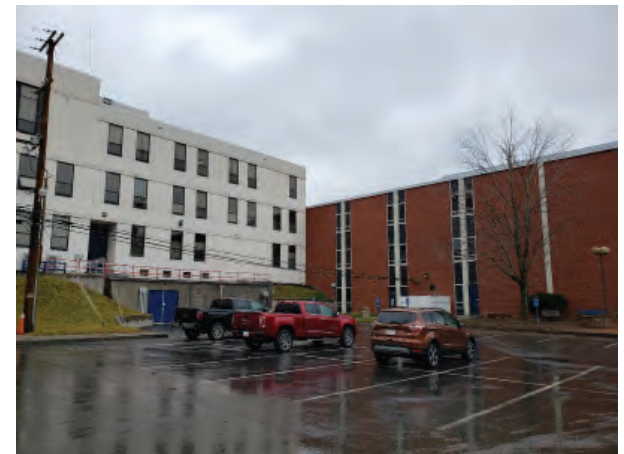
Dickason Hall is a combination cast-in-place concrete and steel frame construction. The exterior façade consists of brick, painted cast-in-place concrete, metal wall panels, and exterior insulation finishing system (EIFS). All exterior windows are aluminum, while the doors are a combination of aluminum and steel. The roof is a membrane system and it has been replaced. The brick, metal wall panels, and painted concrete are in good structural condition. A professional cleaning and repainting of the concrete should periodically be performed. Cracks are visible in the EIFS façade and porticos. All should be repaired to prevent moisture infiltration. The majority of the existing windows are in poor condition. Perimeter caulking and glazing sealant is deteriorated with visible signs of moisture infiltration. It is recommended

that all windows ultimately be replaced. All exterior entrance doors at the fourth level of the original building and first level of the addition will ultimately need to be replaced.

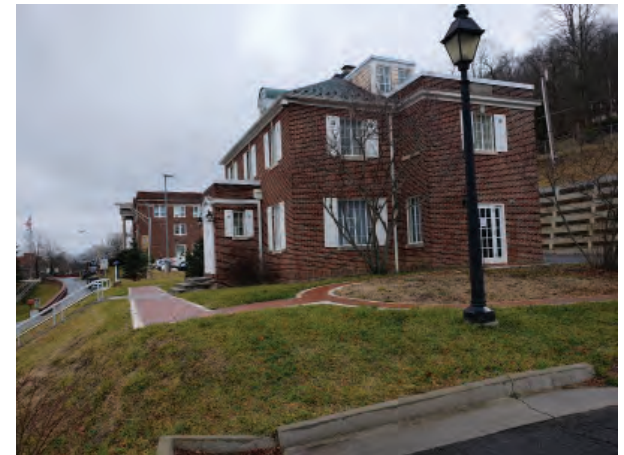
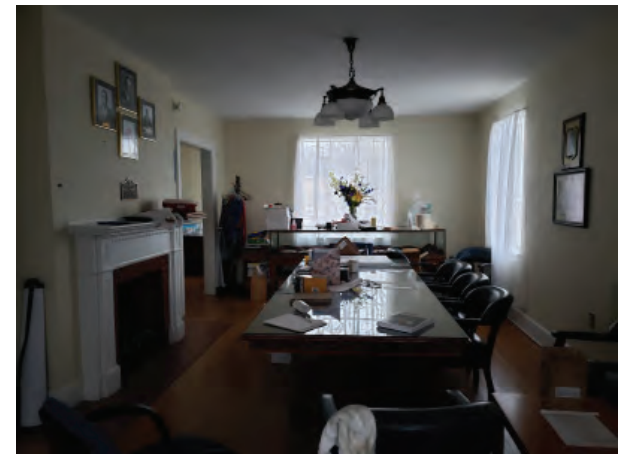
The brick are in good condition. However, select areas of re-pointing are recommended where mortar is loose or missing. Select pieces of stone parapet coping are in need of replacement and all stone trim is in need of professional cleaning. All eaves are in need of repainting. Existing windows are in good condition with no visible signs of leaks. The existing roof systems are in fair condition; however, complete replacement is recommended. There is

an apparent leak above room 302 which should be investigated and repaired in the interim. Gutter repair is necessary on the rear of the building to prevent future moisture damage. All exterior doors are in fair condition but need repainting. The French patio doors on the west façade require adjustment to operate smoothly and new hardware.

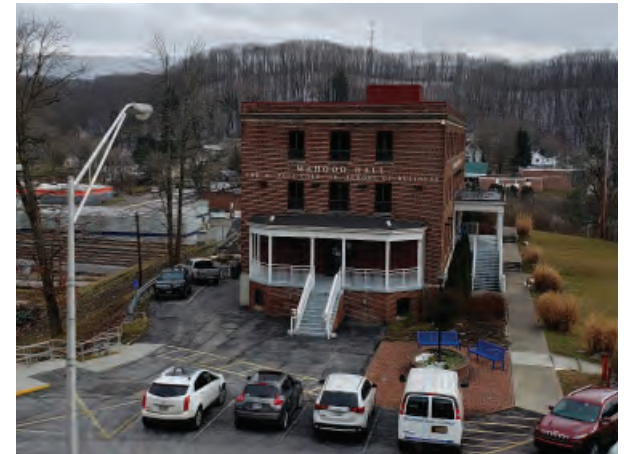
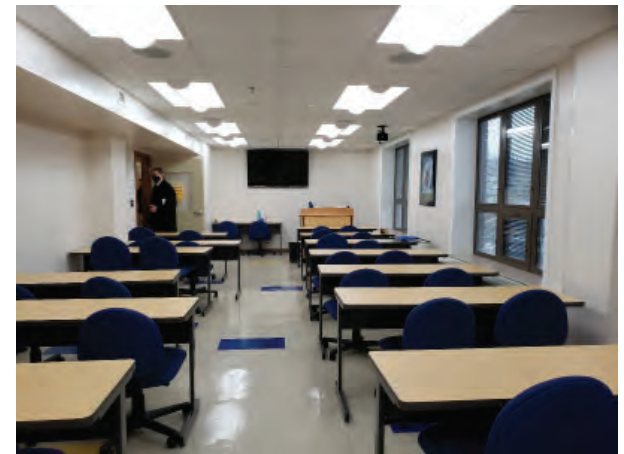
The brick and stone trim are in good condition. However, select areas of re-pointing are recommended where mortar is loose or missing. All windows, doors, and roof system were replaced as part of the renovation effort and are in like new condition. All plumbing vents should be extended as they are shorter than the overflow drains, and roof drains are in need of cleaning to remove soil/vegetation. Both may be handled as maintenance items.

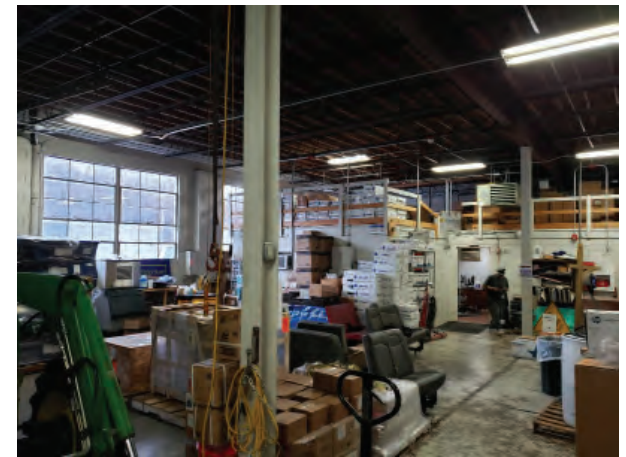
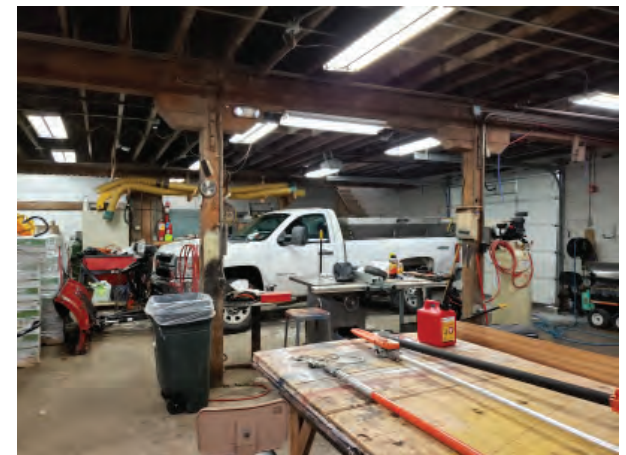
The building exterior walls are in fair condition but in need of repainting. All windows, doors, door hardware, overhead coiling doors, and overhead door operators are at the end of their life cycle and should be replaced at some point in the future. All roofing was recently replaced and is in like new condition.

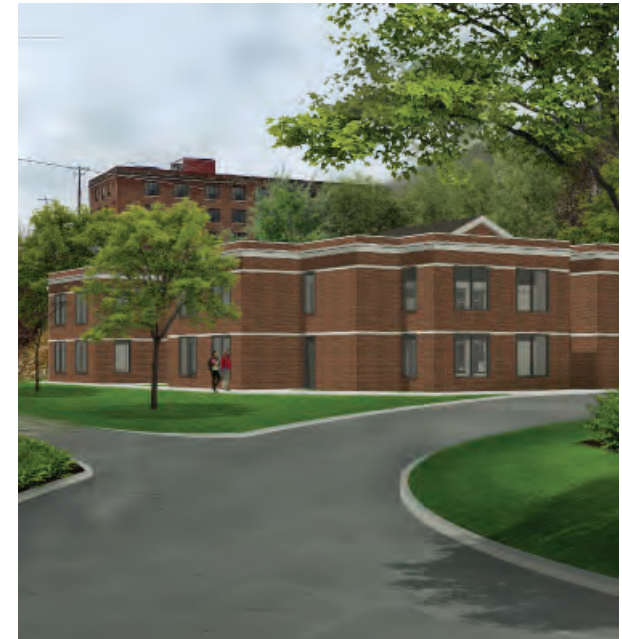
Heritage Village Student Residence Hall (Edward Tucker Architects - design, SmithGroup - illustration)

rooms are appropriate for sophomores and juniors who are transitioning from the very social traditional style to the independent apartment style. Because every suite has a kitchen, it is less important that the Othello Harris-Jefferson Student Center cafeteria provide a wide food selection for every meal every day.

By way of its Agreement with the College, the Collegiate Housing Authority will eventually convey the ownership of Heritage Village to the College.

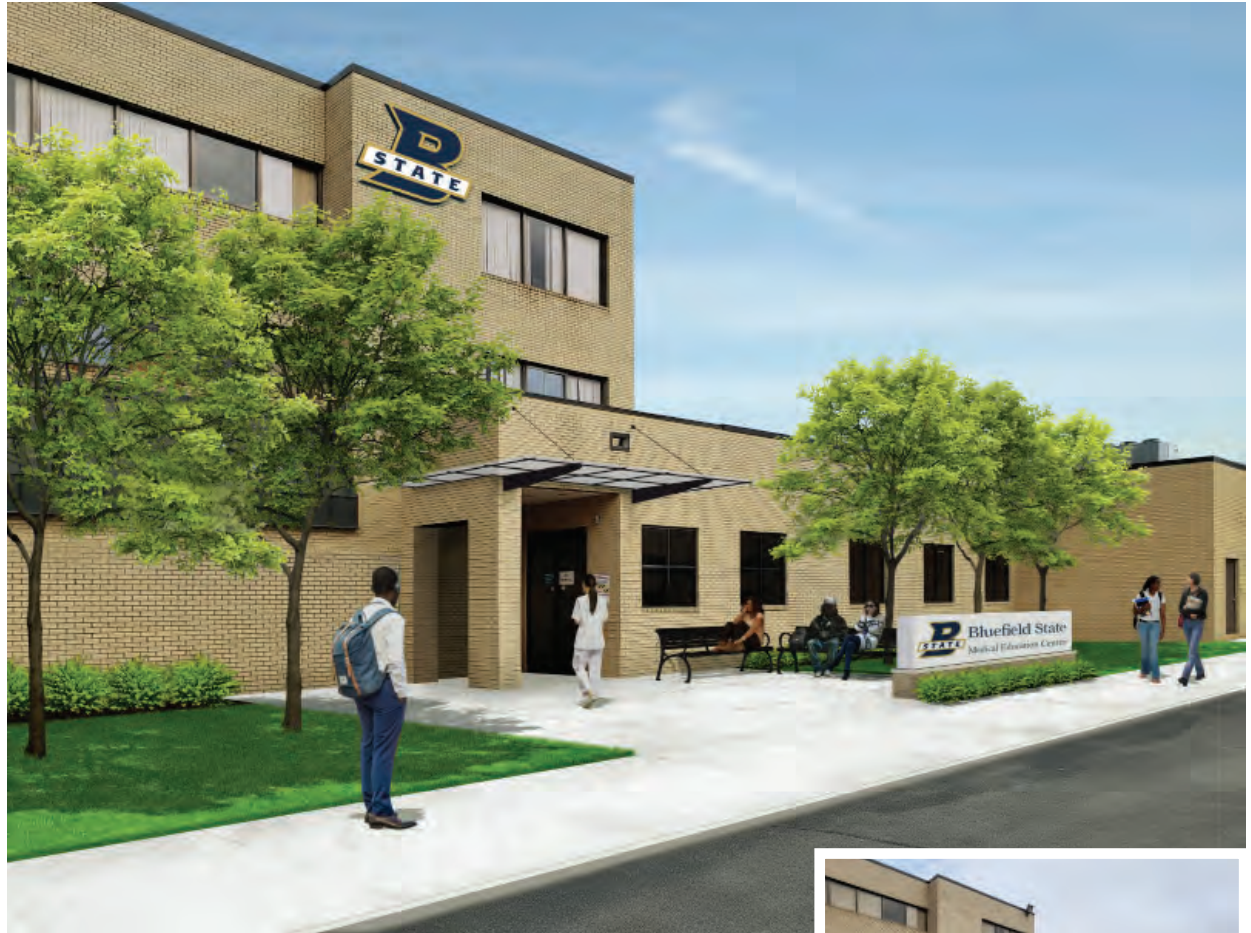
Proposed School of Nursing and Allied Health Entrance (above), Existing (right)

The College will repurpose the existing exit on the west side the second floor to serve as the primary entrance for the academic area. Ample parking is present for commuters at this entrance to the Medical Education Center.

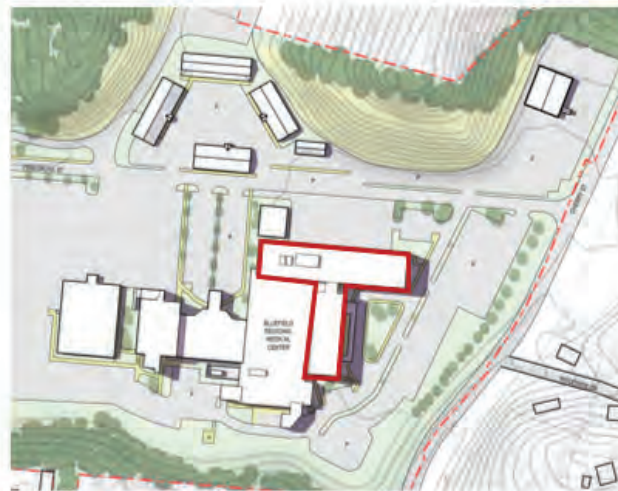
POTENTIAL CONFIGURATION OF
FLOORS 3 AND 4

3rd Floor - 108 Beds

4th Floor - 96 Beds

**206 Total Potential
Traditional Beds**

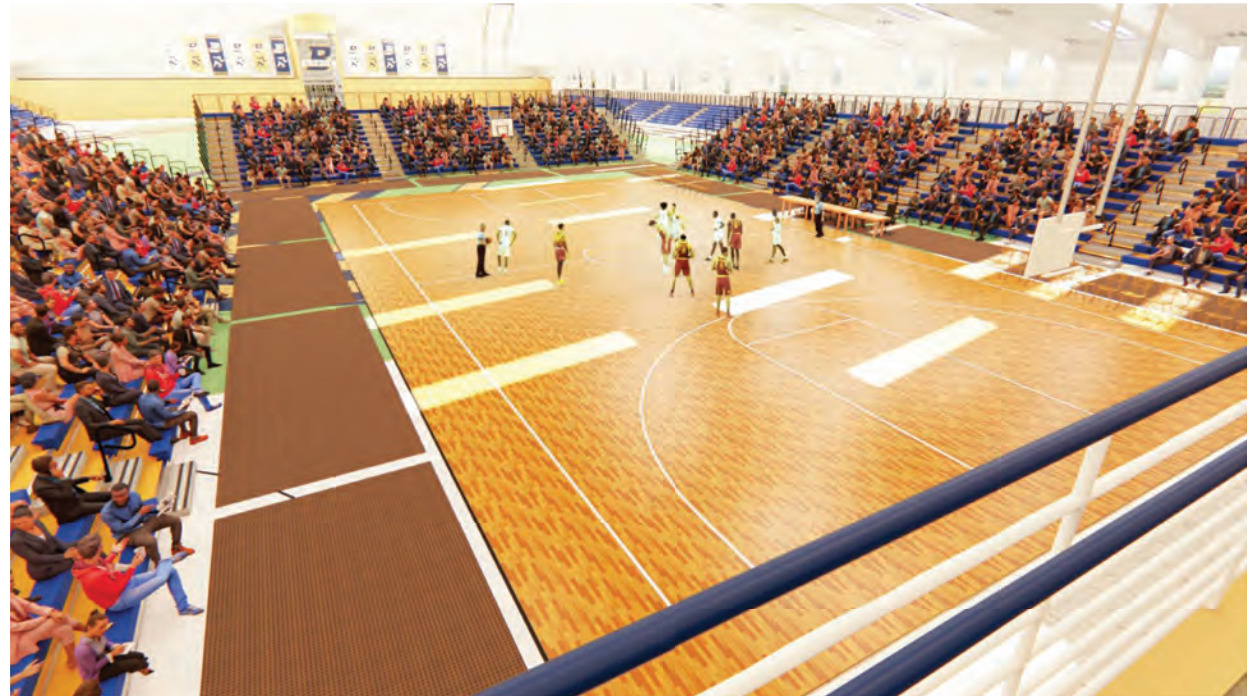
Convocation Center, Basketball Configuration (Edward Tucker Architects)

In collaboration with the Bluefield Regional Sports Authority and the City of Bluefield, the College should construct a convocation center in the far west parking lot. The facility should accommodate both men's and women's basketball practice and competition and NCAA indoor track and field practice and competition, and other sports. The basketball floor can be laid over the track and field floor; portable bleachers can serve both sports. Other school and community events will utilize the convocation center.

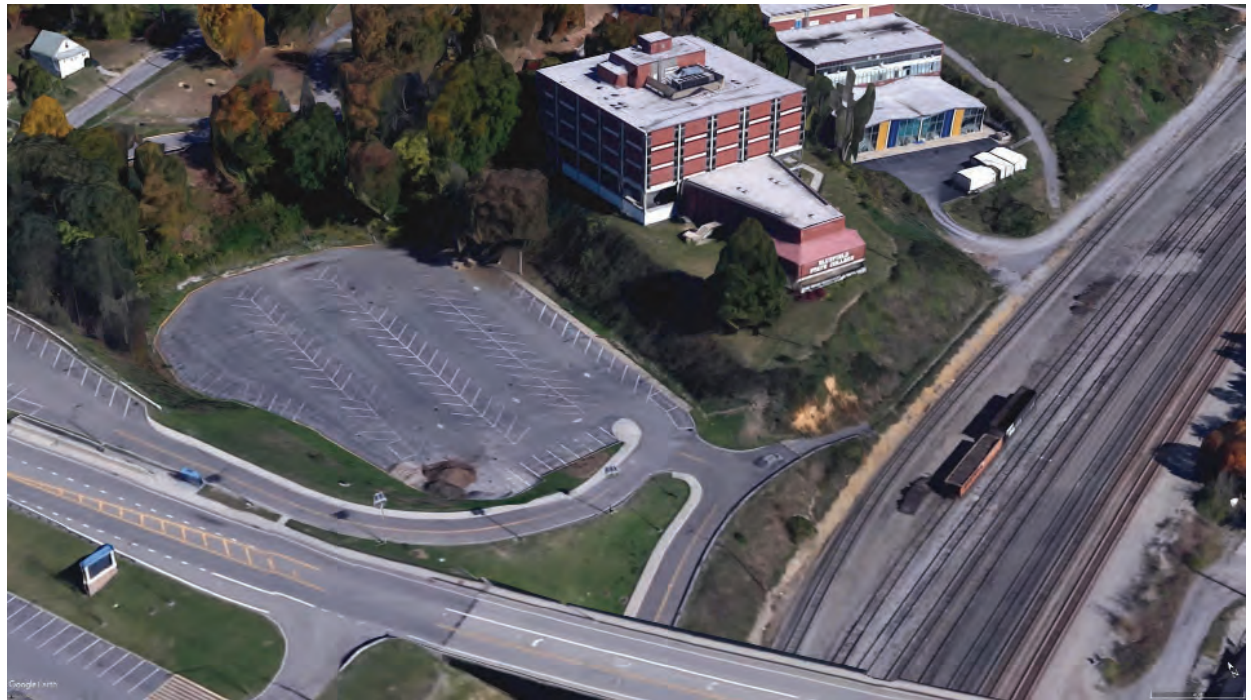
Pit parking lot (left foreground), Ned E. Shott Physical Education Building (right background) (Google Earth)

The College will convert the Pit parking lot into a green space for recreational use. A heritage memorial garden and walking paths may be added.

- Replace storm drain system at Cottages – The existing system is greatly deteriorated and appears to be inadequately sized.
- Improve drainage at Pit parking lot – The existing storm drainage system in the Pit parking lot (west of the Brown-Gilbert Basic Science Building) has several drainage structures and pipes that need to be replaced. It is recommended that these structures and pipes be replaced and additional structures and pipes be added to facilitate several poorly drained areas along the northern side of the parking lot.

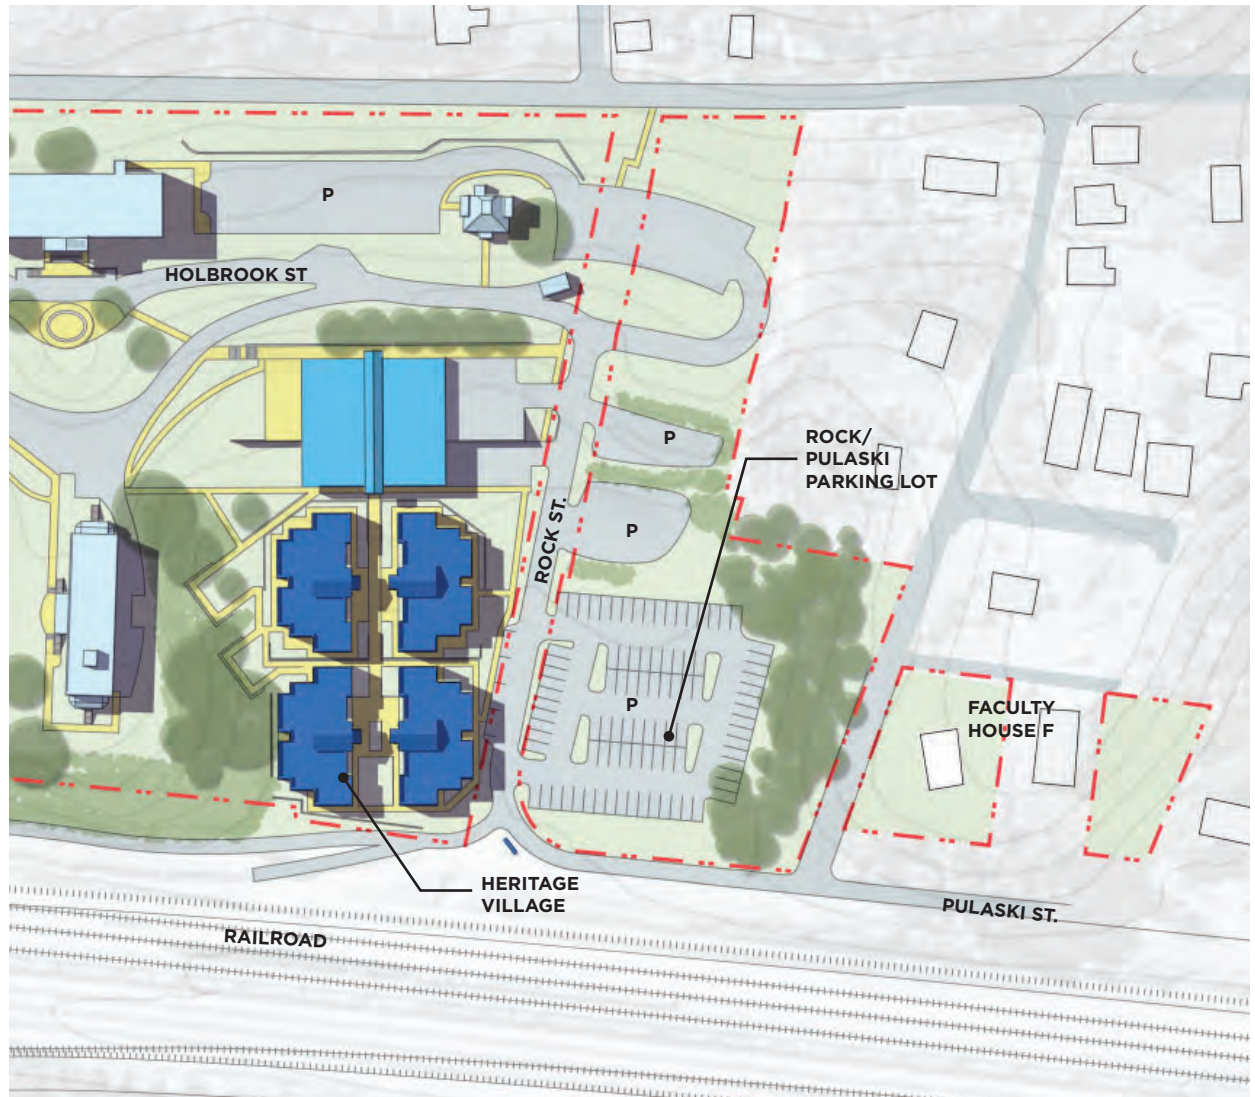
PROPOSED PARKING LOT LAYOUT

The College will construct a surface parking lot on the northeast corner of Rock Street and Pulaski Street. In 2020 Diversified Energy Company granted and released to the College the two parcels which comprise the area. Preliminary lot design suggest a lot capacity of approximately 94 spaces.

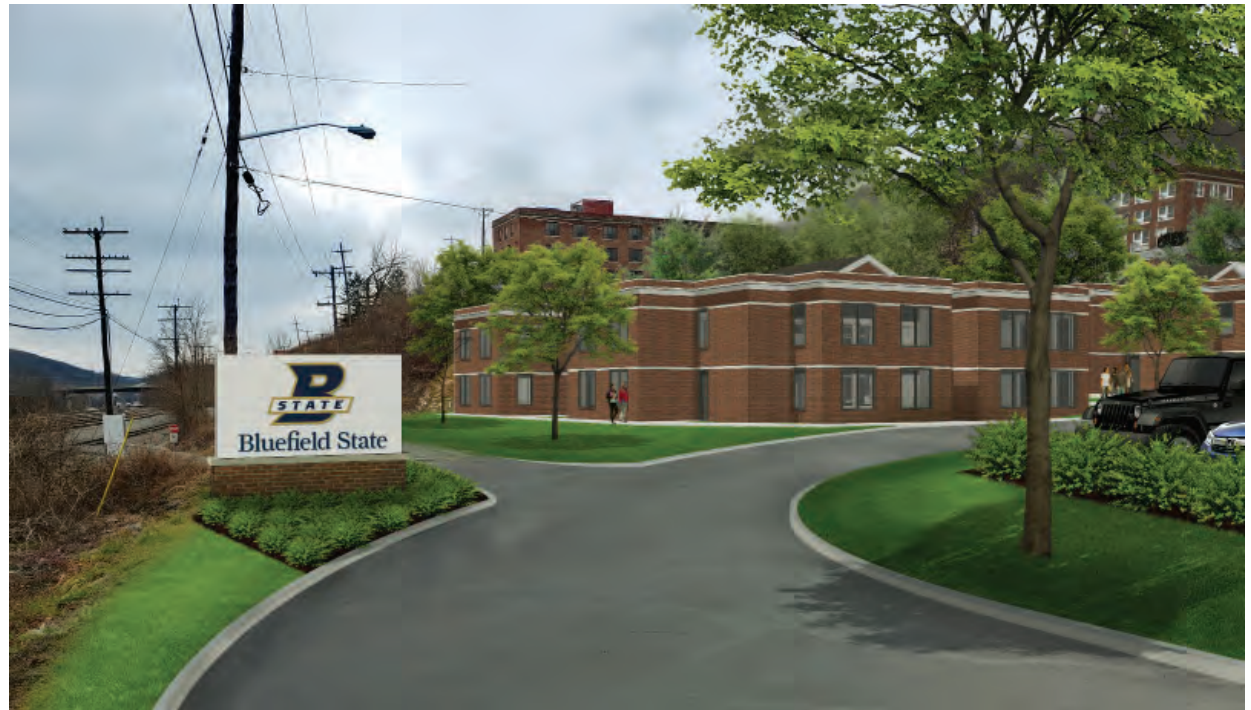
PROPOSED PULASKI STREET GATEWAY, HERITAGE VILLAGE IN BACKGROUND

The intersection should be reconstructed so that Pulaski Street turns (i.e. flows) into Rock Street. The gateway will include edge signage and ground landscaping which promotes the College brand.

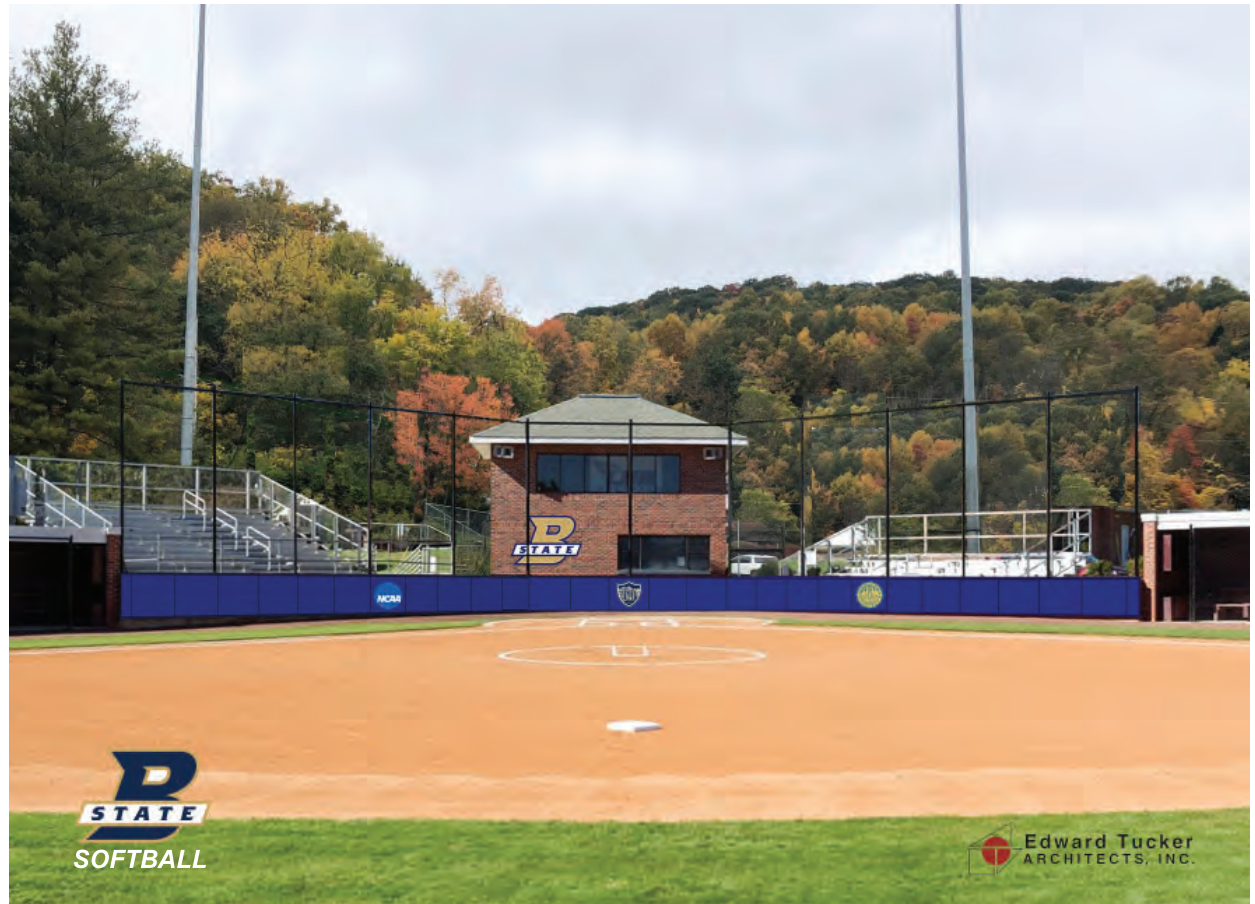
PROPOSED SOFTBALL FIELD (EDWARD TUCKER ARCHITECTS)

The College will develop the June O. Shott Field to a NCAA regulation softball and baseball complex using a common clubhouse.

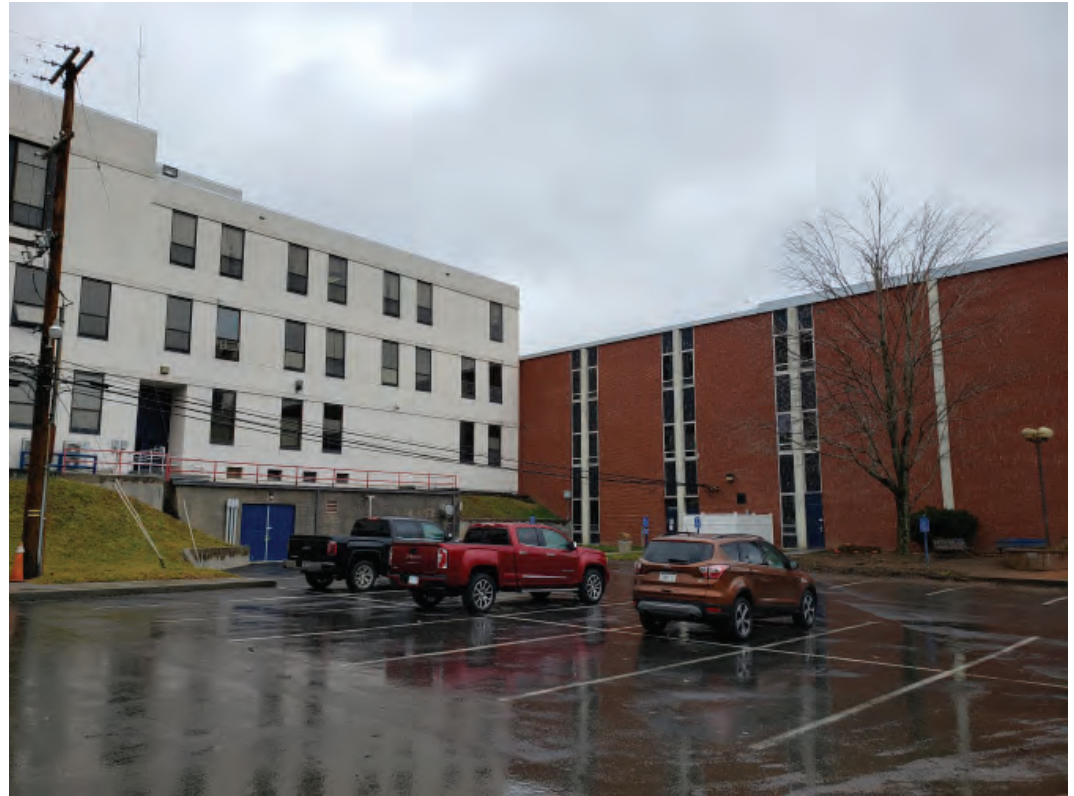
Dickason and Physical Plant (Maintenance) Building Parking

As the age and condition of these lots worsens over time, it is recommended that these lots eventually be repaved and restriped. It is further recommended that the garage area of the Brown-Gilbert Basic Science Building be milled, repaved and restriped, and the lot at the Physical Plant (Maintenance) Building be reconfigured and repaved to provide improved operational access.

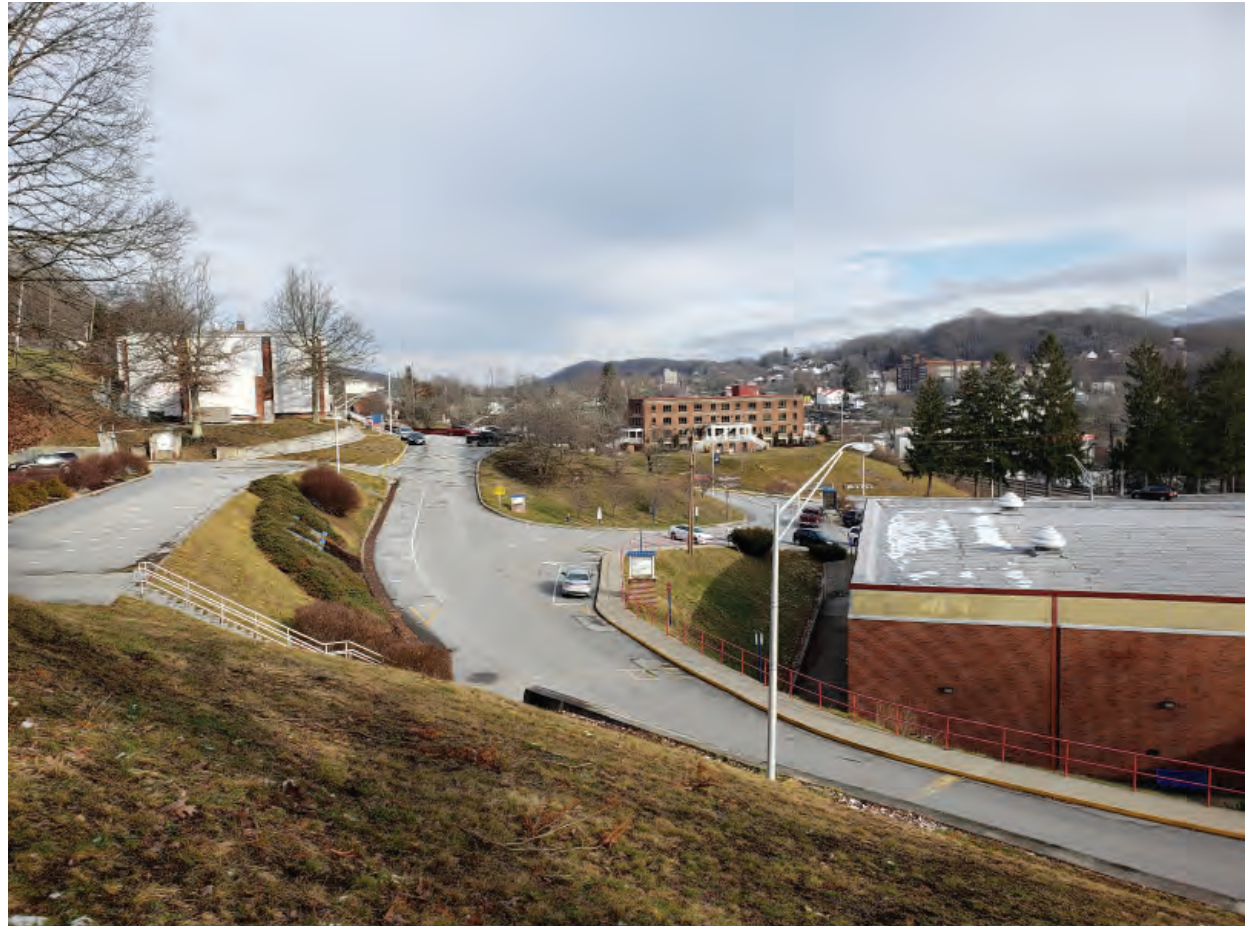
Lawn on steep slopes

In the early 20th century, the campus was described as the “terraced hills” for its verdant landscaping. Currently there are 33 acres of the campus that depend on lawn maintenance, and most of this land is on steep terrain. Campus lawn areas require an extraordinary amount of maintenance that includes mowing, seeding, fertilizing, and weeding, not to mention the amount of maintenance required to keep the equipment running in good condition.

The College should prepare a campus landscape master plan that reduces the amount of lawn while also improving the character of campus. The landscape master plan should consider removing turf in areas difficult to maintain and planting groundcovers, shrub massings, and tree cover that requires less maintenance.
