Bluefield State College

**CAMPUS DEVELOPMENT PLAN
2021 UPDATE**

SMITHGROUP

Prepared December 2020-April 2021

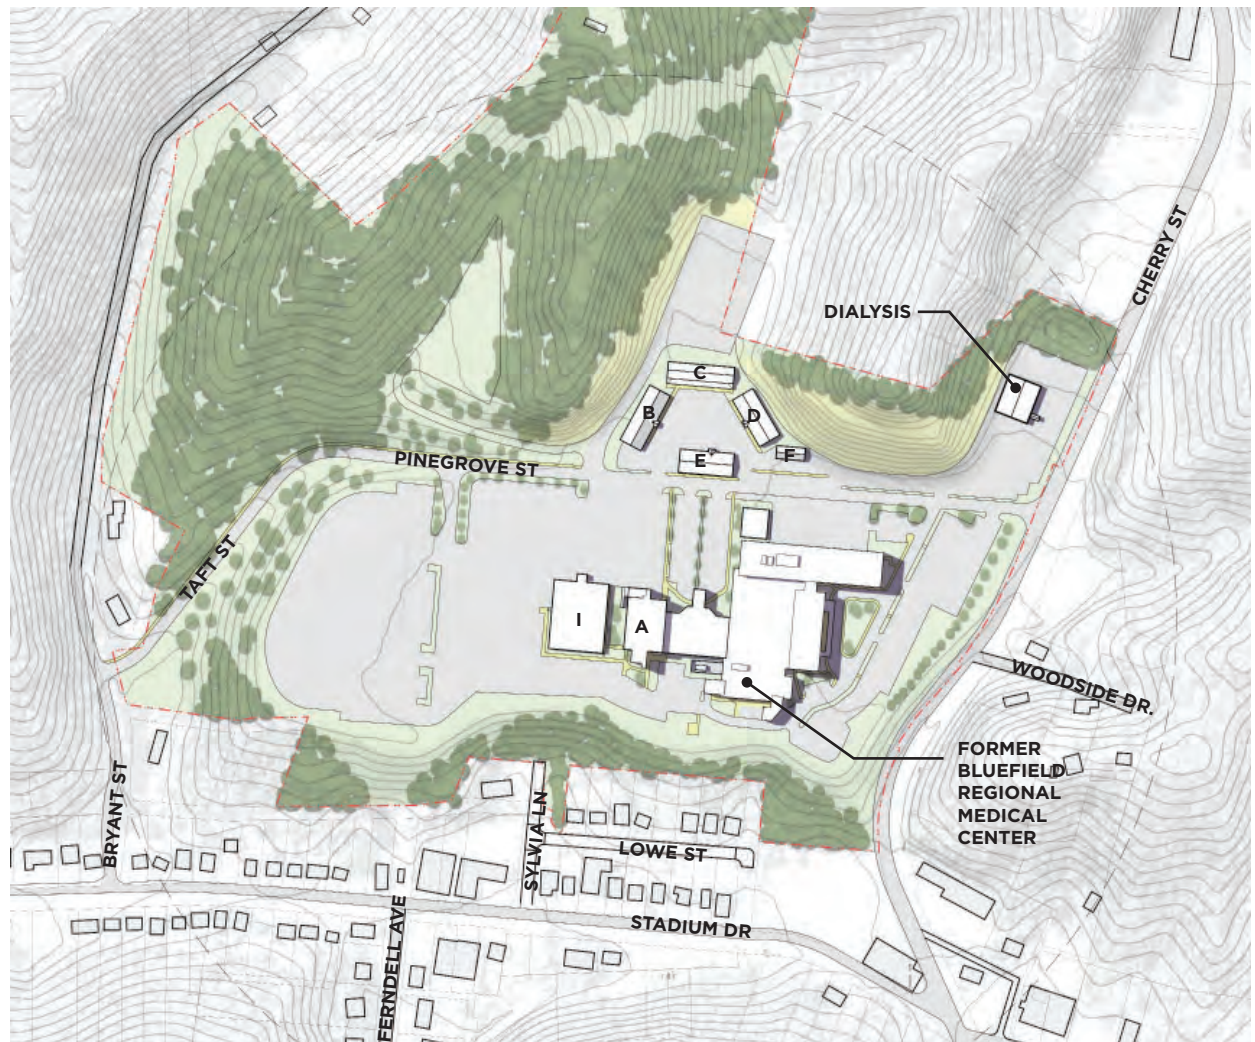
BLUEFIELD STATE MEDICAL EDUCATION CENTER EXISTING SITE

The Bluefield State Medical Education Center is relatively disconnected from its host community. While it lies along a major community vehicular route, due to topography, the center has no adjacent neighbors and its self-contained. The area contains approximately 70 acres, mostly flat, and has ample parking.
